# Whitepaper on Clad Metal Repairs

September 24, 2018

Alex Orr

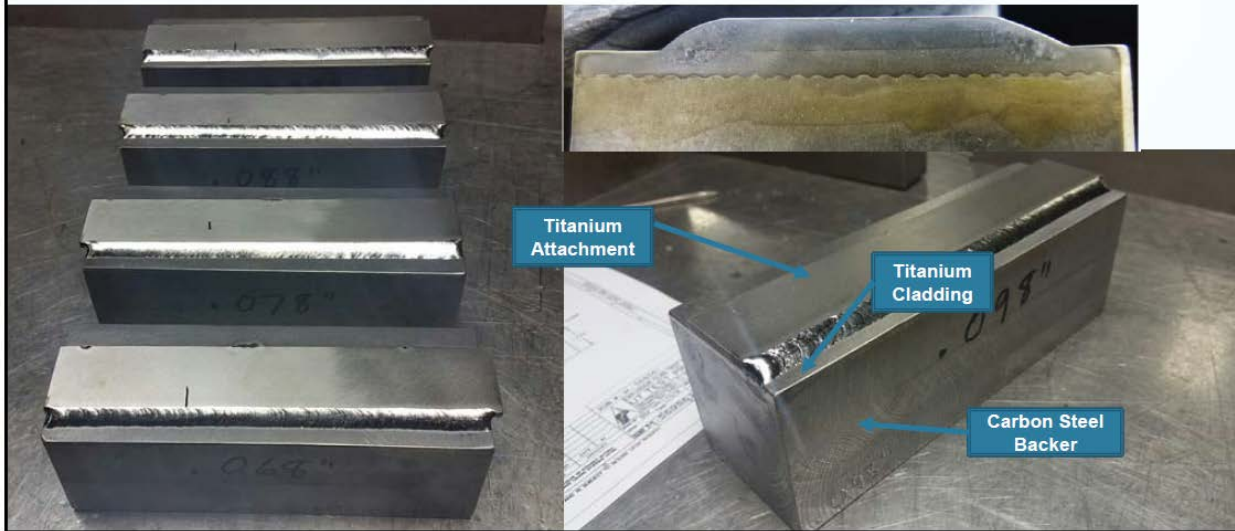
**Figure 4: Test Blocks**

To explore this issue doing repairs on clad equipment where the thickness is reduced from design, trials were performed in Tricor's shop by experienced welders using proven methods on 2" x 2" x 8" blocks with cladding on one 2" x 8" face. The various cladding thicknesses tested were: 0.098" (original design), 0.088", 0.078", and 0.068", 0.058", 0.048", 0.038" and 0.028". Stereoscopic images of the heat affected zone from welding on the repair patch were taken. The weld area and repair patch were evaluated with a Sci Aps XRF PMI gun to look for Fe contamination. That work is summarized here.

## Original Sample Made From 2" X 2" X 8" Blocks

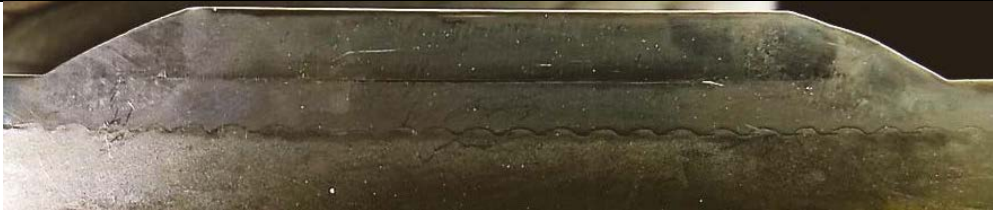
Clad Thickness	After Repair
0.098"

The thumbnail images at various magnifications give some sense of the progressive deterioration of the clad/substrate bond interface as a function of cladding thickness at the time of welding with the described procedure:
